National Park Service Cultural Landscapes Inventory 1998

Doughton Park Blue Ridge Parkway - Highlands District

Inventory Unit Summary & Site Plan

Doughton Park is a recreation area located on the Blue Ridge Parkway between milepost 238 and 246. The landscape is 12 miles southeast of Sparta, North Carolina and 31 miles northwest of Wilkesboro, North Carolina. Covering over 6,000 acres, Doughton Park was one of the first developed areas to be planned for the Appalachian parkway. The parent landscape includes several component landscapes. Bluffs Lodge, Doughton Park Campground, Doughton Park Maintenance Area, Bluffs Coffee Shop and Service Station, Bluffs Picnic Area, Brinegar Cabin, and Caudill Family Homestead are each component landscapes within Doughton Park.

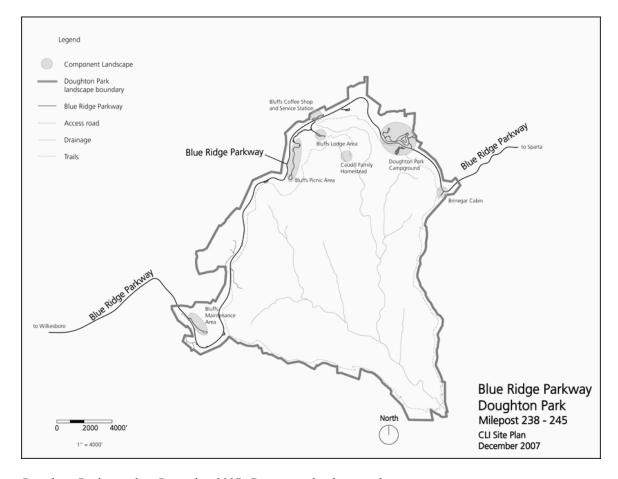
Site Plan

Doughton Park site plan, December 2007. Component landscapes shown in gray.

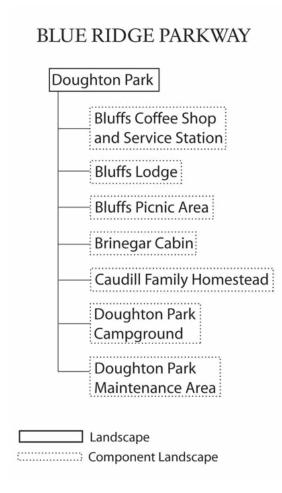
Doughton Park CLI Hierarchy

On the 1936 Blue Ridge Parkway Master Development Plan, Doughton Park (then known as The Bluffs) is shown as one of the proposed parkway developed areas. The 6300-acre site largely consists of forested, steeply-sloping land, with the built environment consisting of rustic trails, overlooks and a shelter. It is listed in the CLI in its entirety as the Doughton Park Developed Area. More intense development was planned for sites closer to the parkway in areas totaling 225 acres in size. Each of these seven sites has a separate developmental history and function and deserves individual listing in the CLI as a component landscape. They are, leading from parkway north to south: Brinegar Cabin, Doughton Park Campground, Bluffs Coffee Shop and Service Station, Bluffs Lodge, Caudill Family Homestead, Bluffs Picnic Area, and the Doughton Park Maintenance Area.

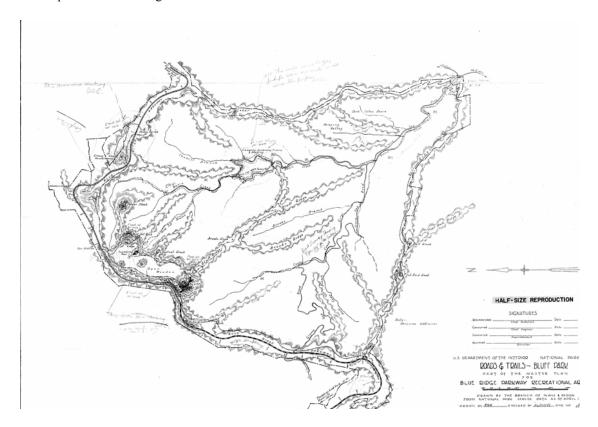
1937 Bluffs Development plan

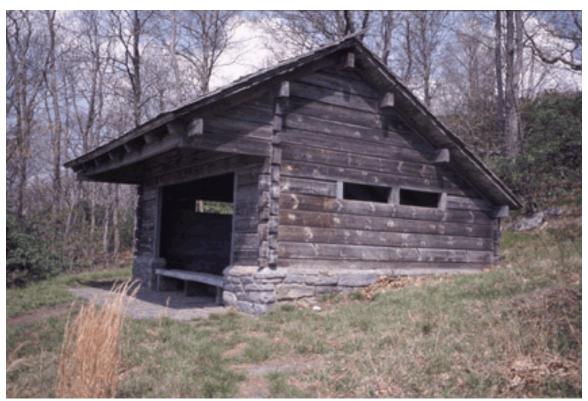
Trail Shelter, Building # 103 (2002).

All buildings constructed through the Pre and Post War periods of Parkway development (1933-1955) contribute to the national significance of Doughton Park, while additional buildings and alterations have a lower level of significance or are considered non-contributing. Water tanks, cabins, lodges, comfort stations, maintenance buildings, residences, and various outbuildings are listed and described in detail in the component landscape inventories.

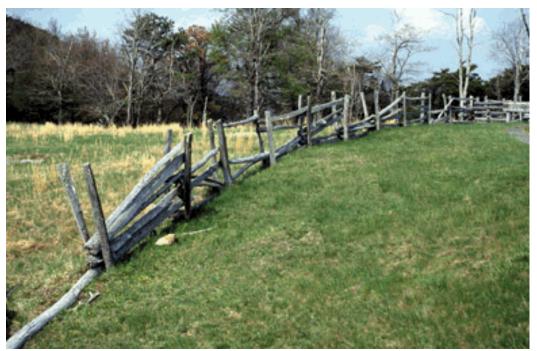
Fence in disrepair (2002)

Many features were built in the rustic or Adirondack style or modified for Mission 66 construction. The material and workmanship are local, though some stone and mortar features have concrete repairs. The Coffee Shop and Service Station small-scale features suffer from neglect and the fireplaces, picnic tables, and drinking fountains have diminished integrity.
